WORLD WAR II GERMAN  
FIRE DOCUMENT TRANSLATIONS

## **WORLD WAR II GERMAN FIRE DOCUMENT TRANSLATIONS**

REPORT OF THE REGIMENTAL COMMANDER OF THE FIRE-PROTECTION POLICE REGIMENT "SAXONY" ABOUT THE COURSE AND RESULTS OF THE MASSIVE AERIAL ATTACKS ON ROTTERDAM ON MAY 14, 1940, AND THE EXPERIENCES DRAWN THEREFROM (by Hans Rumpf) . . . . .	A-1
The Air Defense Fire Service . . . . .	A-1
The German Action to Occupy Rotterdam and the Aerial Attack of May 14 . . . . .	A-2
The Consequences . . . . .	A-3
The Organization of the Rotterdam Fire Department . . . . .	A-12
Efforts of the Voluntary Fire Department of Rotterdam After the Great Aerial Attack of May 14 . . . . .	A-21
Losses of the Rotterdam Fire Department . . . . .	A-24
Eyewitness Accounts . . . . .	A-25
Comments on the Foregoing Eyewitness Accounts . . . . .	A-40
The Renewed Superiority of Effects of Fire . . . . .	A-44
Additional Observations . . . . .	A-55
Appendix (to Rumpf's Report) . . . . .	A-71

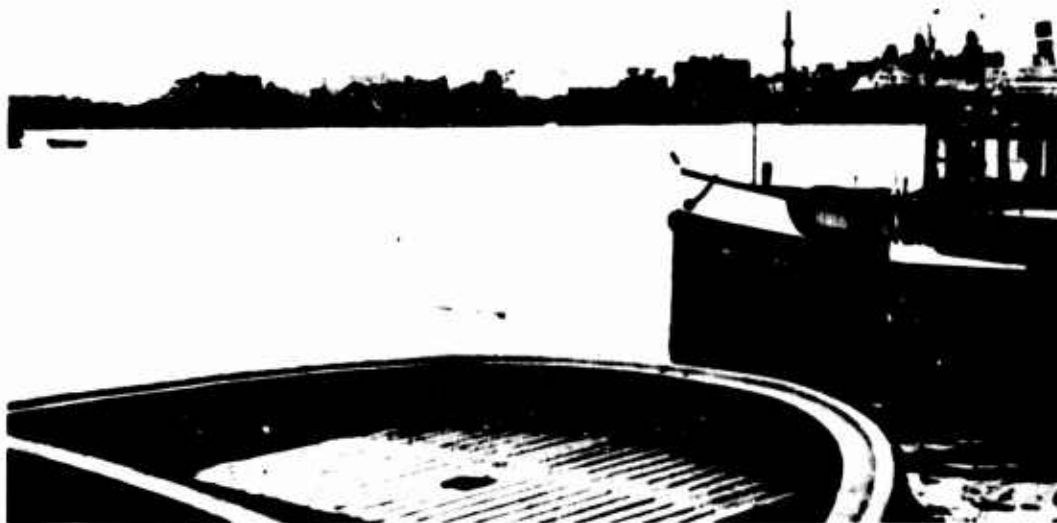
At the same time, great fires raged on the other side of the Maas River across from the island in the installations of the Holland-America Line (Picture 1). At that time, the fire on the 28,000-ton passenger liner "Staatendam" of the Holland-America Line took place, caused by shelling by Dutch artillery. This was the flagship of the Dutch merchant marine (Picture 2). Fire-fighting activities by the fire department were initiated, but no real success in putting out the fire was achieved. On Sunday, May 12, in the morning, an air attack by German stukas on the navy barracks took place, and the barracks were in flames a short time afterwards. Fire fighting was allegedly curtailed because of a shortage of water; the main waterline received a direct hit. Thermal radiation and flying sparks ignited a block of houses on Hoogstraat, and they burned to the ground. Nothing of the navy barracks was saved.

**Picture 1 GUTTED WAREHOUSES AND STORAGE DEPOTS OF THE HOLLAND-AMERICA LINE**

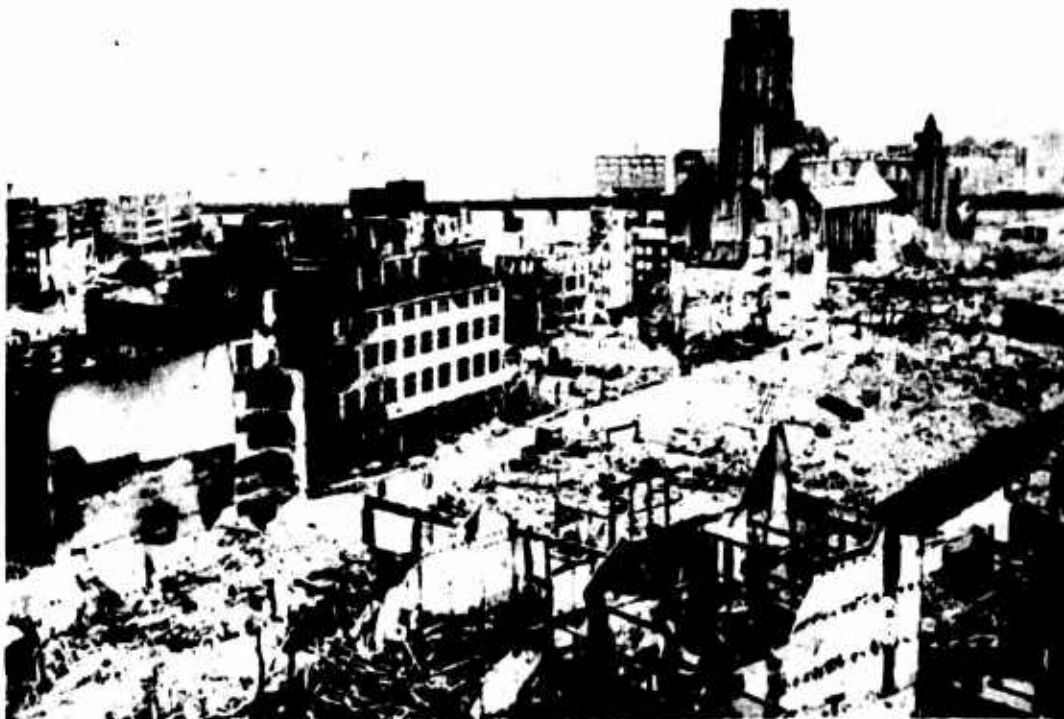
**Picture 3** VIEW FROM THE SKYSCRAPER SHOWING THE FIELD OF RUINS OF THE DESTROYED INNER CITY (SEE CITY MAP, FIGURE 1). Because the skyscraper is not located in the center, but on the southeast corner of the field of ruins, the borders of the latter to the east and north cannot be seen on the picture.

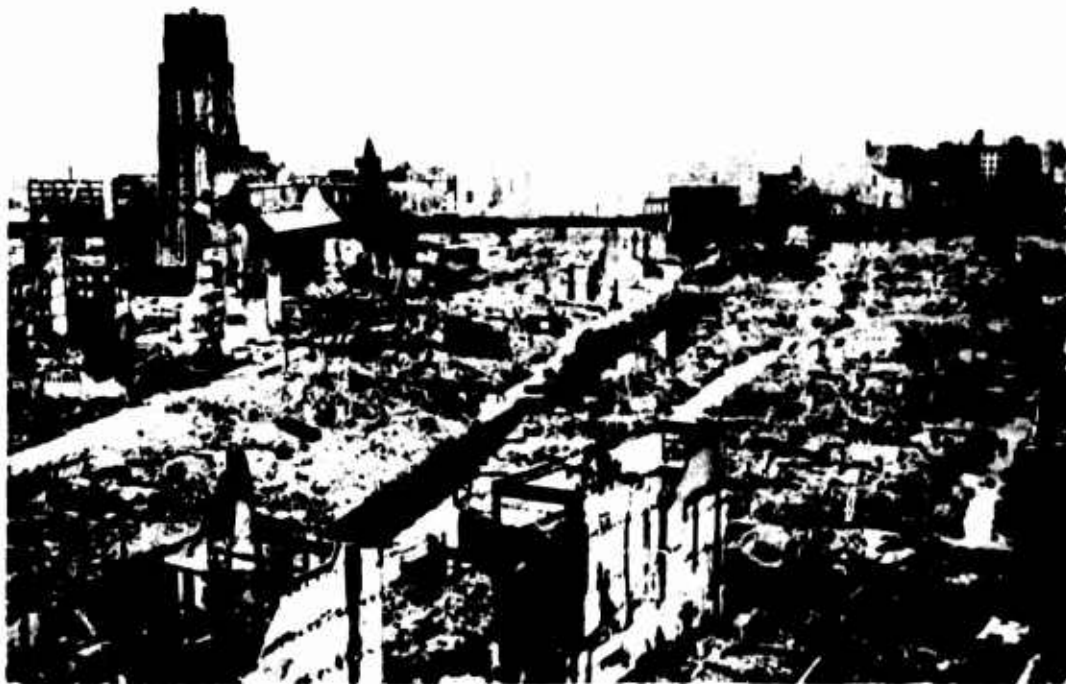
**Picture 8 OVERHEAD RAILWAY AND DAMAGED AREAS OF THE INNER CITY NEAR THE HARBOR**

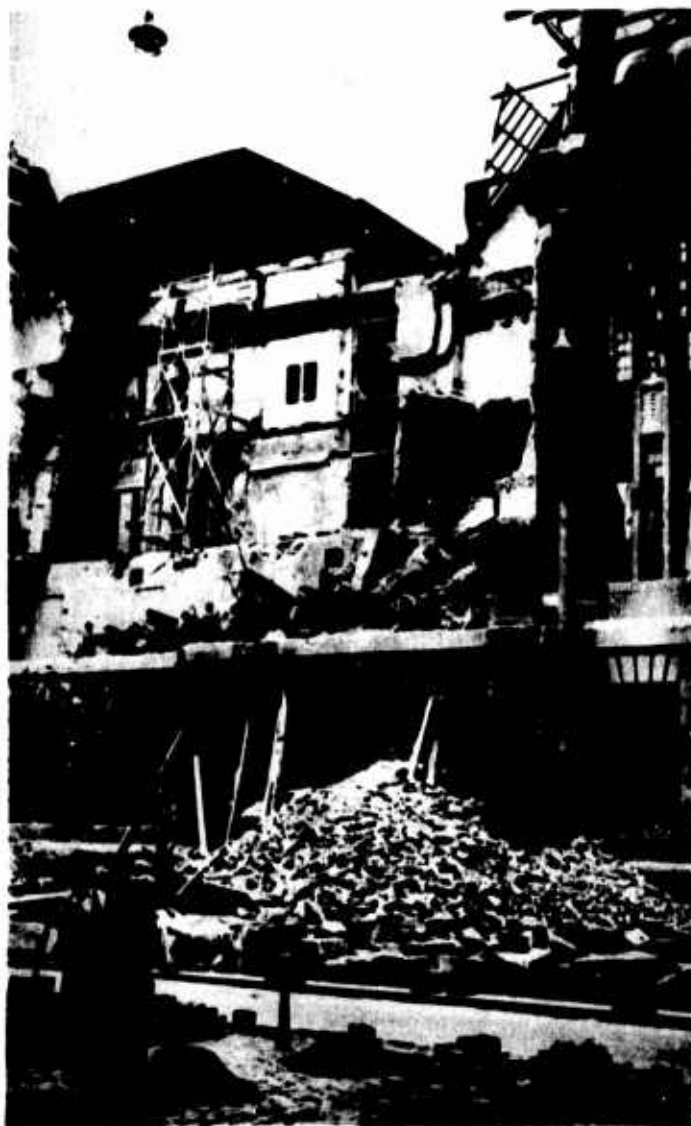
**Picture 25** DIRECT HIT ON POST OFFICE BUILDING (NEXT TO THE CITY HALL; SEE CITY MAP, FIGURE 1). An example of pure high explosive bomb effects, i.e., hits from high explosive bombs that did not ignite.

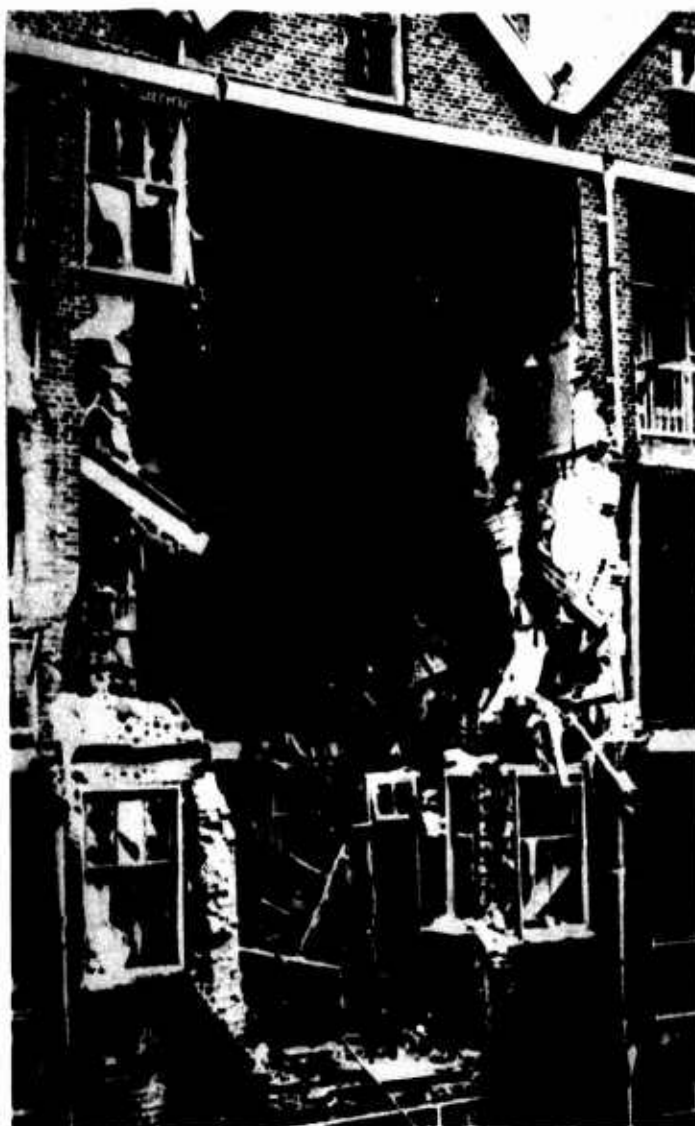
**Picture 26** DIRECT HIT ON A RESIDENTIAL HOUSE. The bomb did not drop vertically through the roof but at an angle from above into the front wall of the house.

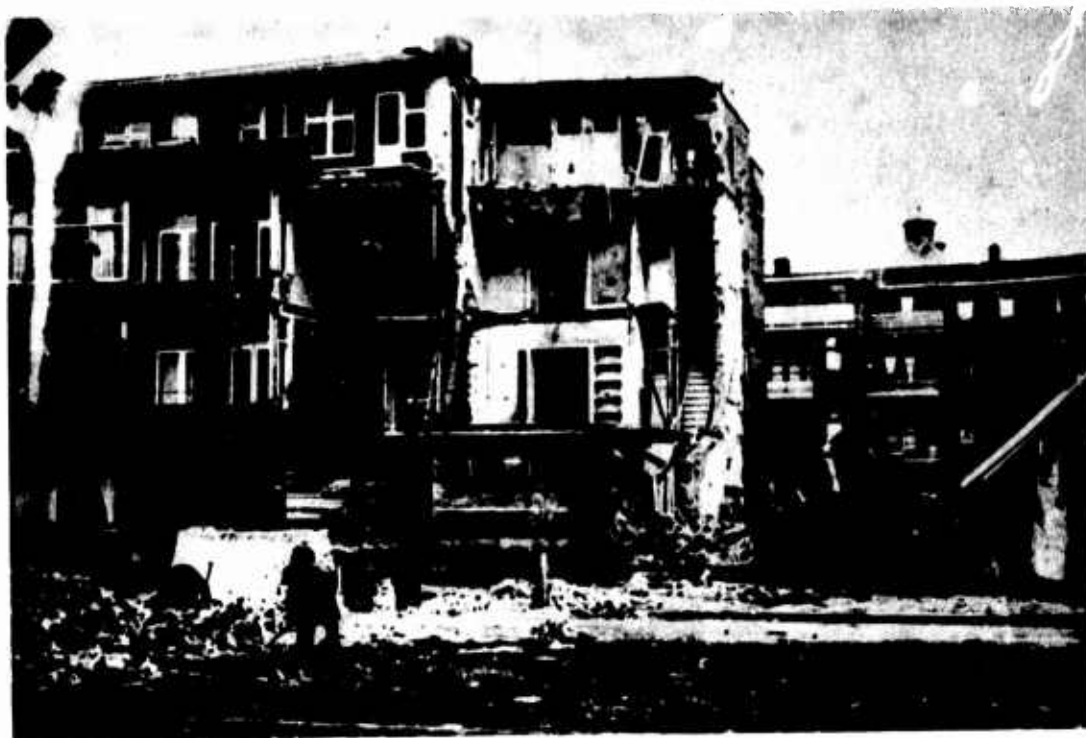
Pictures 27, 28 HOUSES DAMAGED BY BLAST ONLY

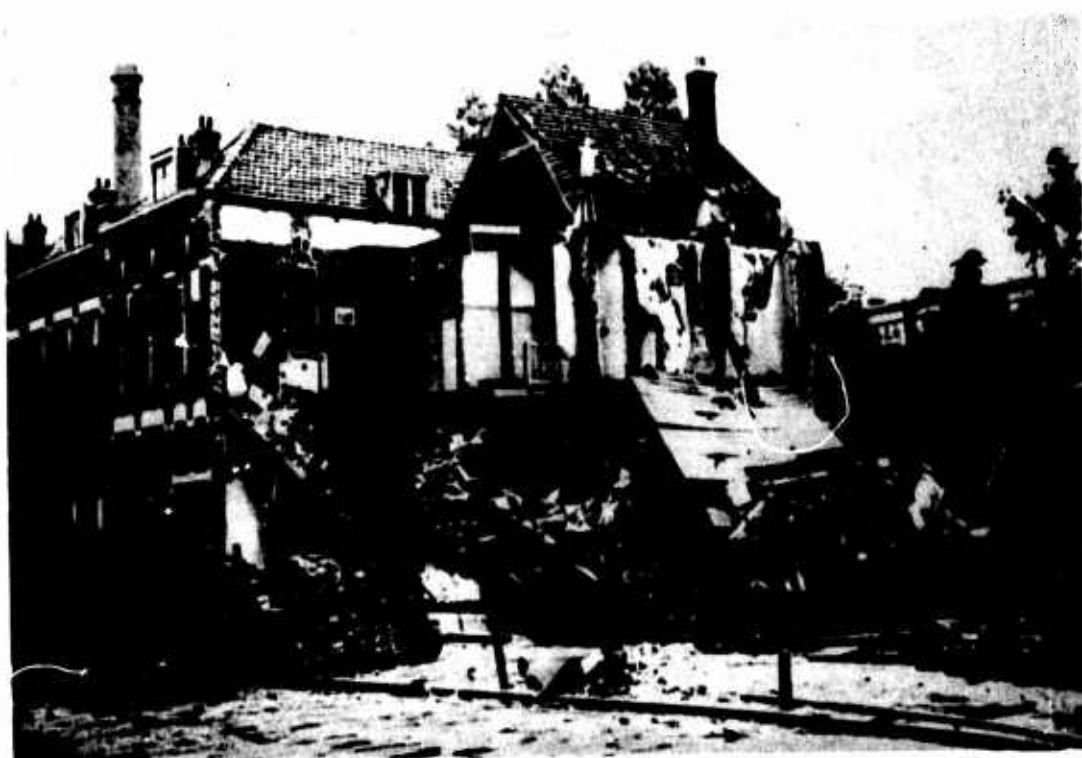
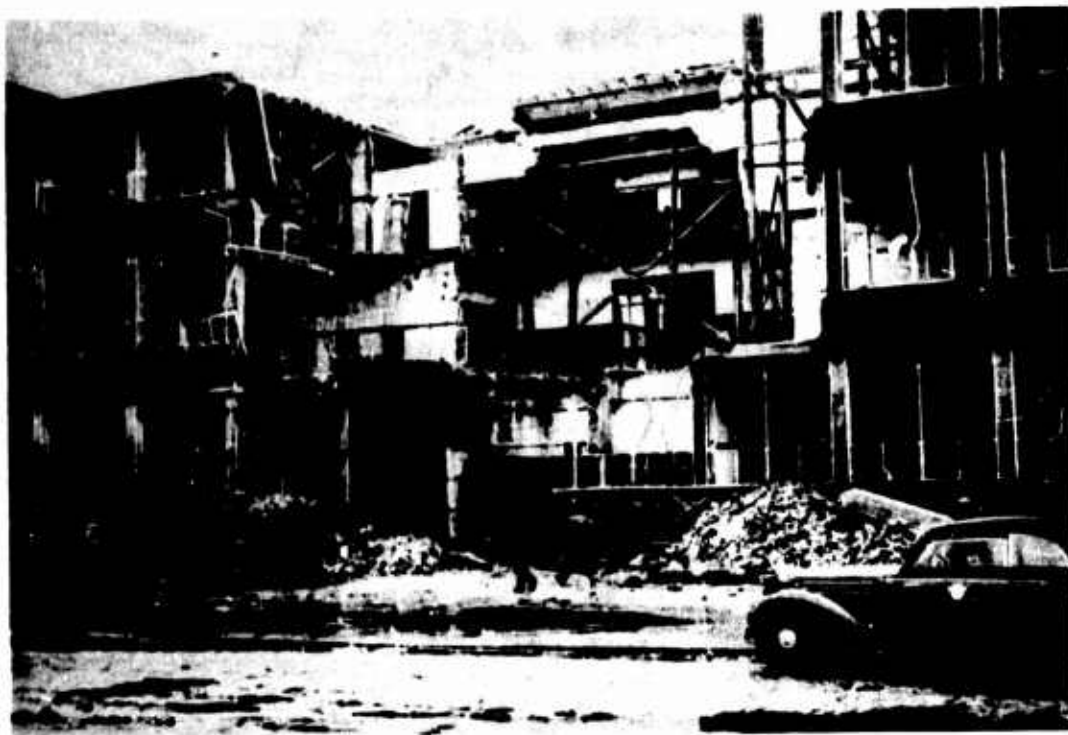
**Pictures 29, 30 BOMB HITS ON BUSINESS BUILDINGS THAT CAUSED PARTIAL DESTRUCTION  
BUT DID NOT DESTROY THE BUILDING COMPLETELY**

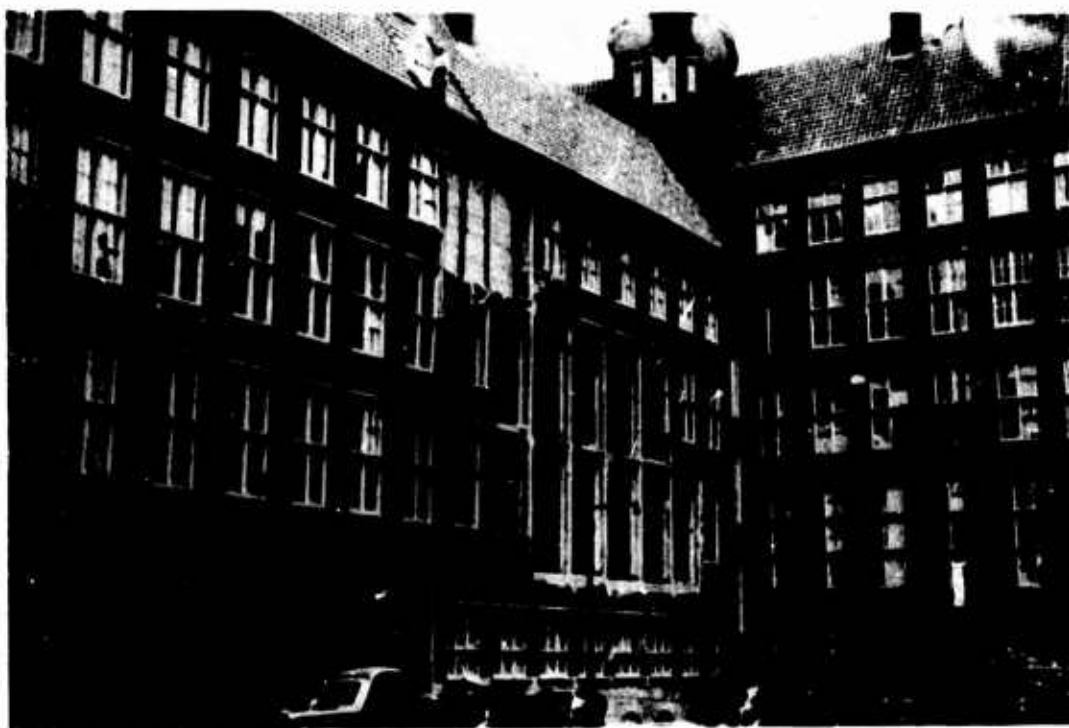
Practically nowhere did the debris clearing crews find any beams, girders, posts, planks, doors, or window frames made of wood among the debris. Also, the fire sites of former purely residential districts were free of wood. The Dutch use wood as a building material, though not to the extent as in Germany. All this wood was burned. If the ruins had resulted from high explosive bombs, the wood would have been found among the debris (see Pictures 31 and 32).

**Pictures 31,32 FIRE-DESTROYED STRUCTURES.** All wooden parts, like beams, floors, doors, window frames, and shafts are completely burned. The fire sites are completely free of wood.

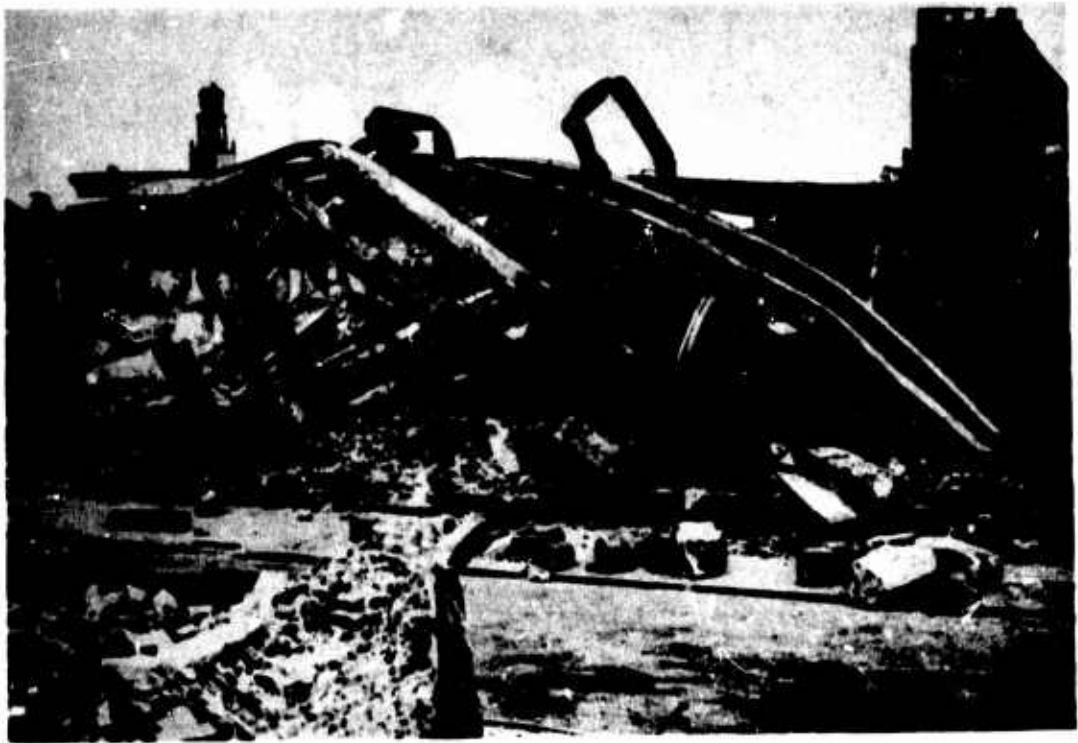
A characteristic of fire ruins is the tangle of twisted metal. With the exception of a few buildings which received a direct hit by a high explosive bomb and were left standing without burning (see Pictures 25 to 30), all parts of the field of ruins show the typical destruction by fire, with the metal supports twisted by heat and fire (see Pictures 33 to 42).

**Pictures 33, 34 TWISTED STRUCTURAL STEEL, CHARACTERISTIC OF STRUCTURES  
DESTROYED BY FIRE**

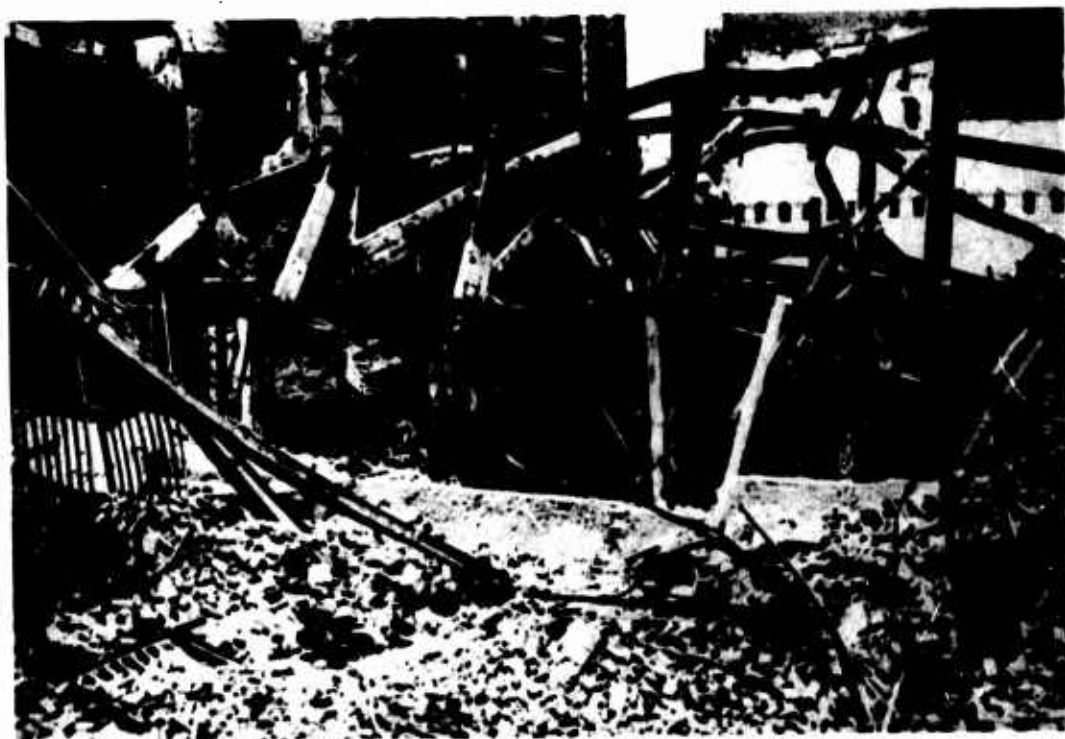
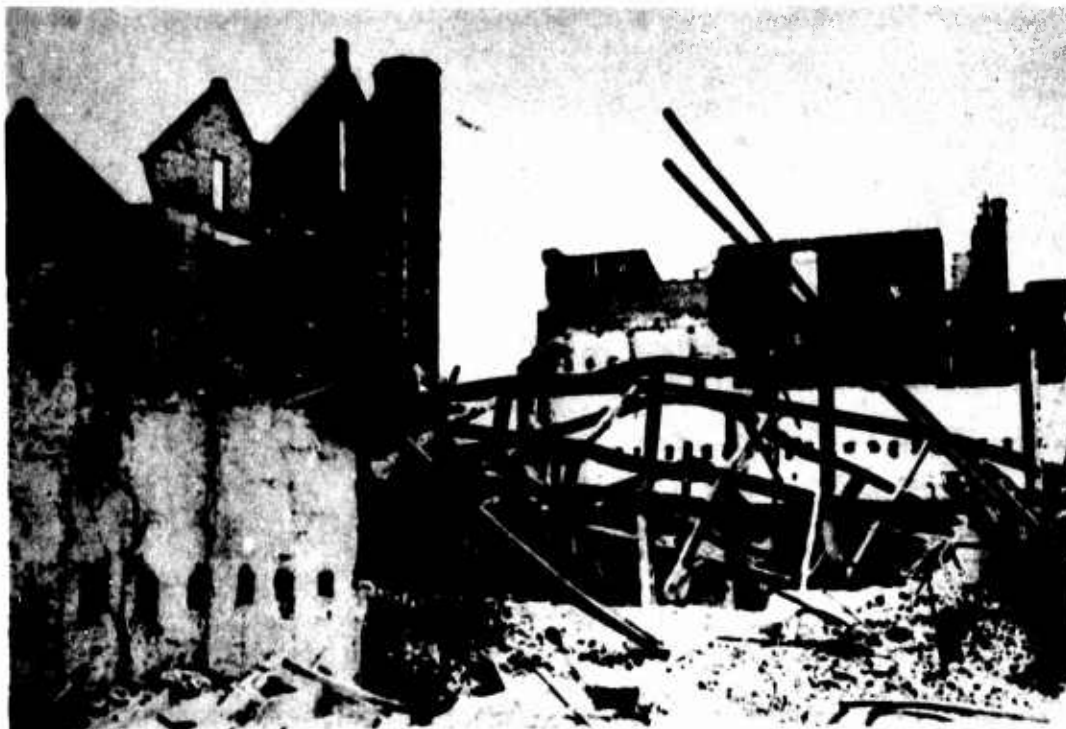
**Pictures 37, 38 TWISTED STRUCTURAL STEEL, CHARACTERISTIC OF STRUCTURES DESTROYED BY FIRE**

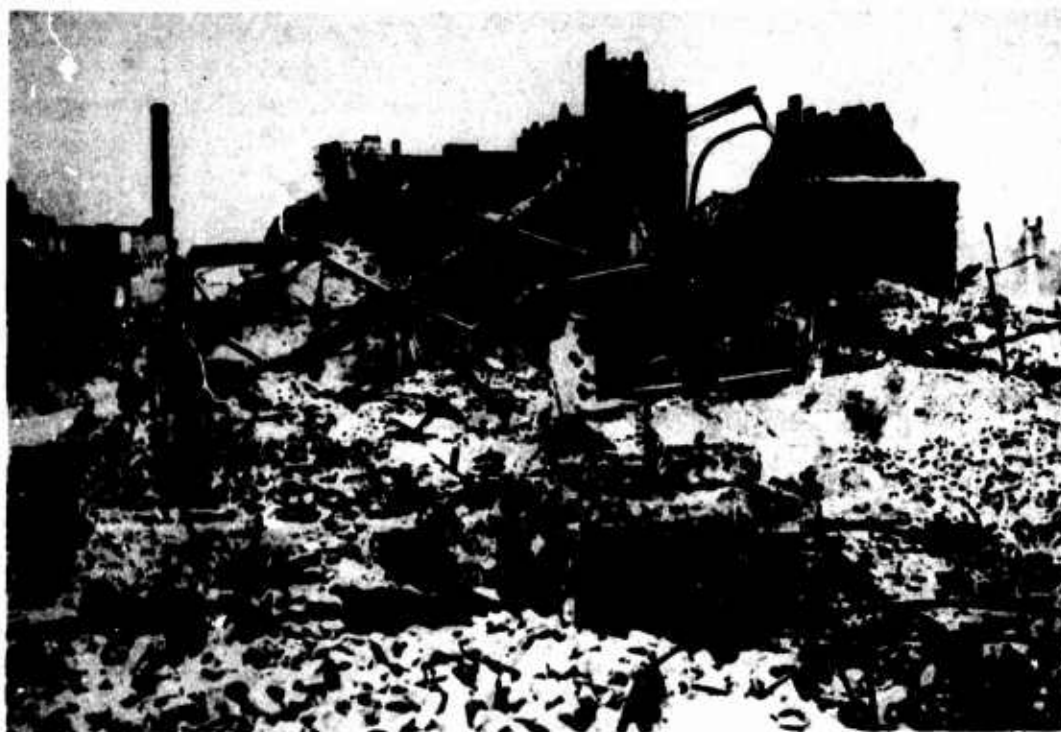
**Figures 39, 40 TWISTED STRUCTURAL STEEL, CHARACTERISTIC OF STRUCTURES DESTROYED BY FIRE**

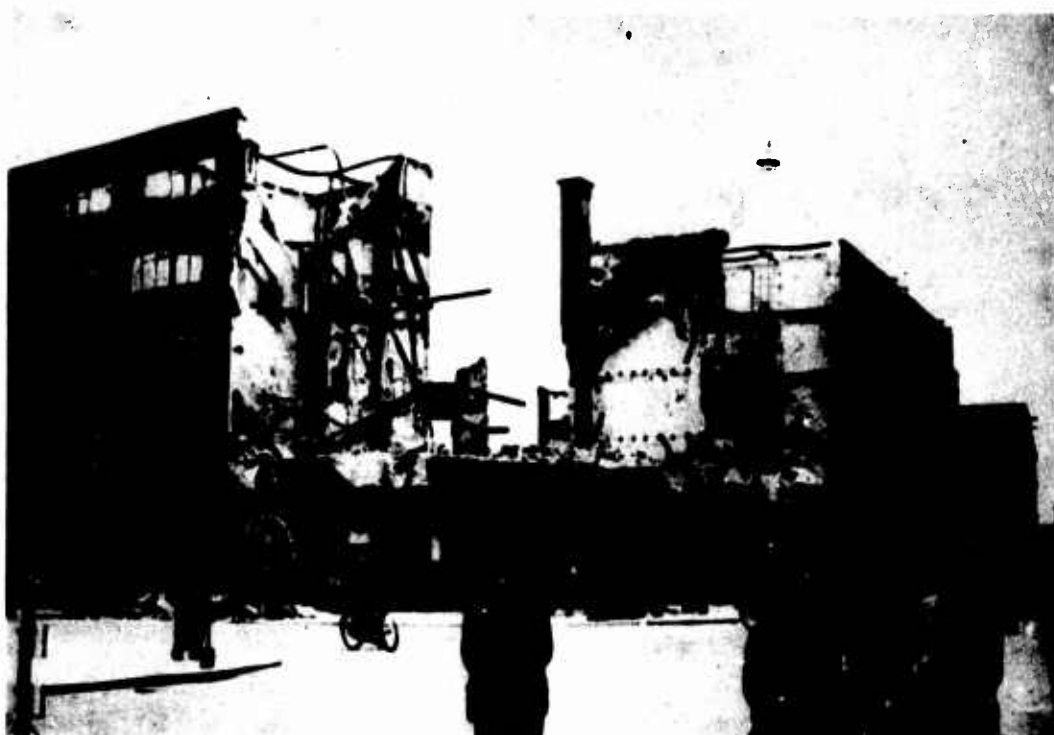
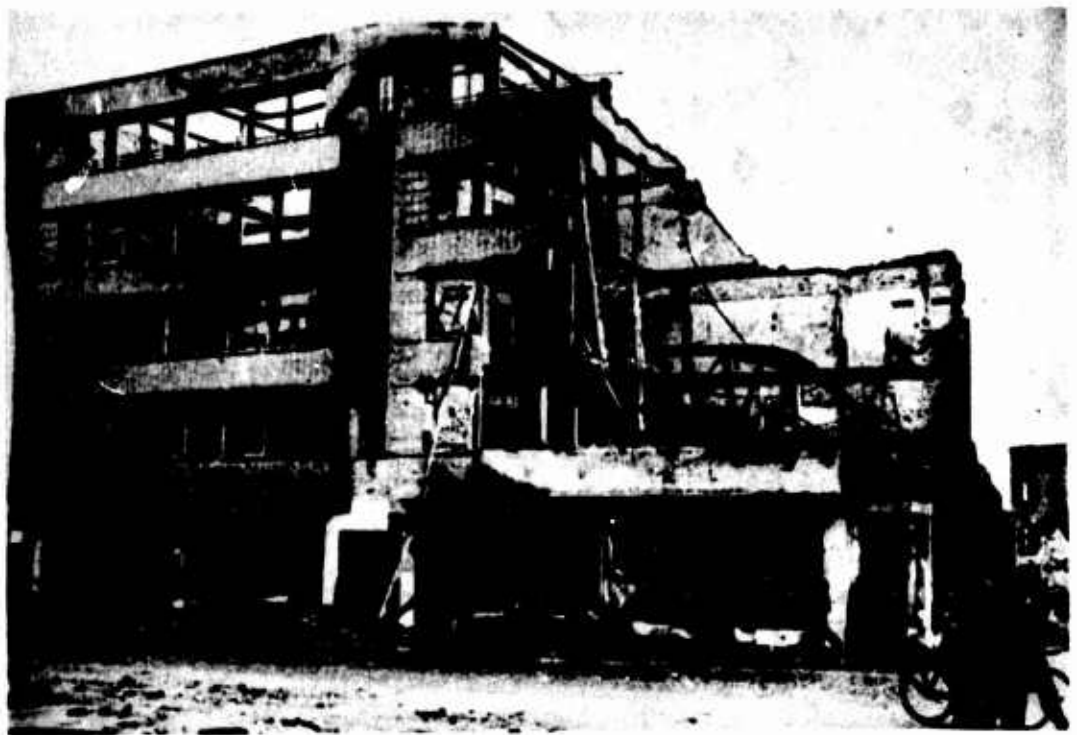
**Pictures 41, 42 TWISTED STRUCTURAL STEEL, CHARACTERISTIC OF STRUCTURES DESTROYED BY FIRE**

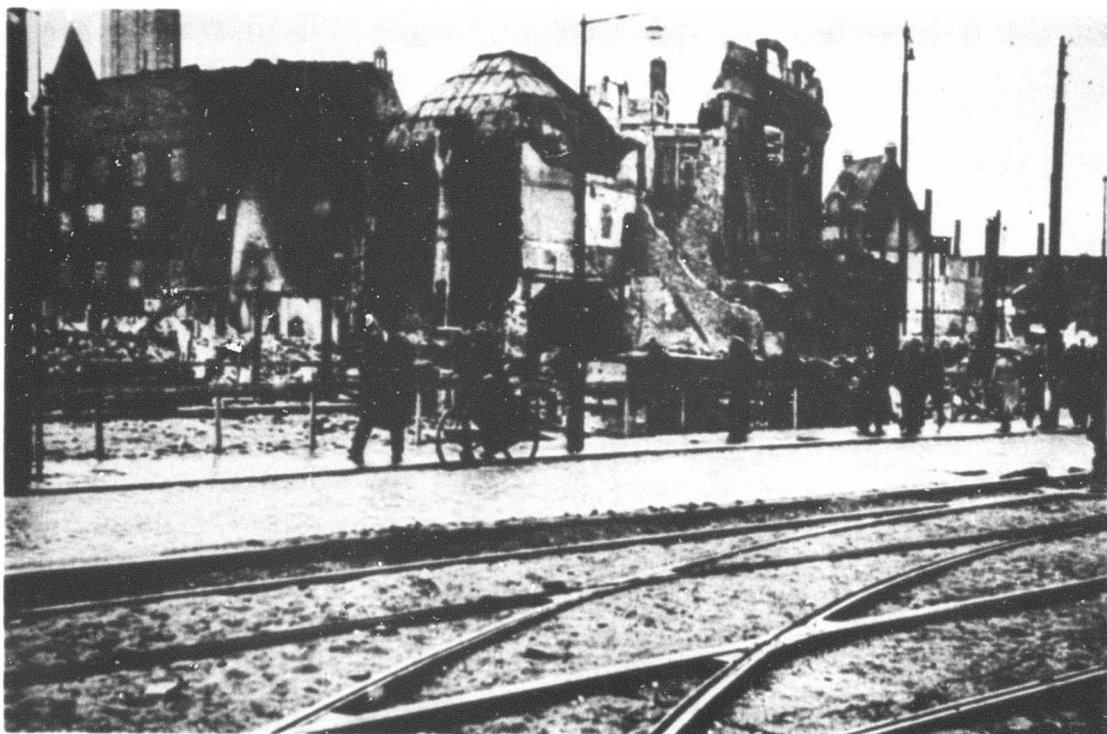
Also, from the outside the countless blackened facades of remaining buildings show plainly that the destruction was accomplished by fire and not through the force of high explosive bombs (Pictures 43 to 55).

Pictures 43, 44 PICTURES OF SOOT-BLACKENED HOUSE FRONTS WHICH CLEARLY SHOW THAT DESTRUCTION WAS CAUSED BY FIRE AND NOT BY DETONATION OF HIGH EXPLOSIVE BOMBS

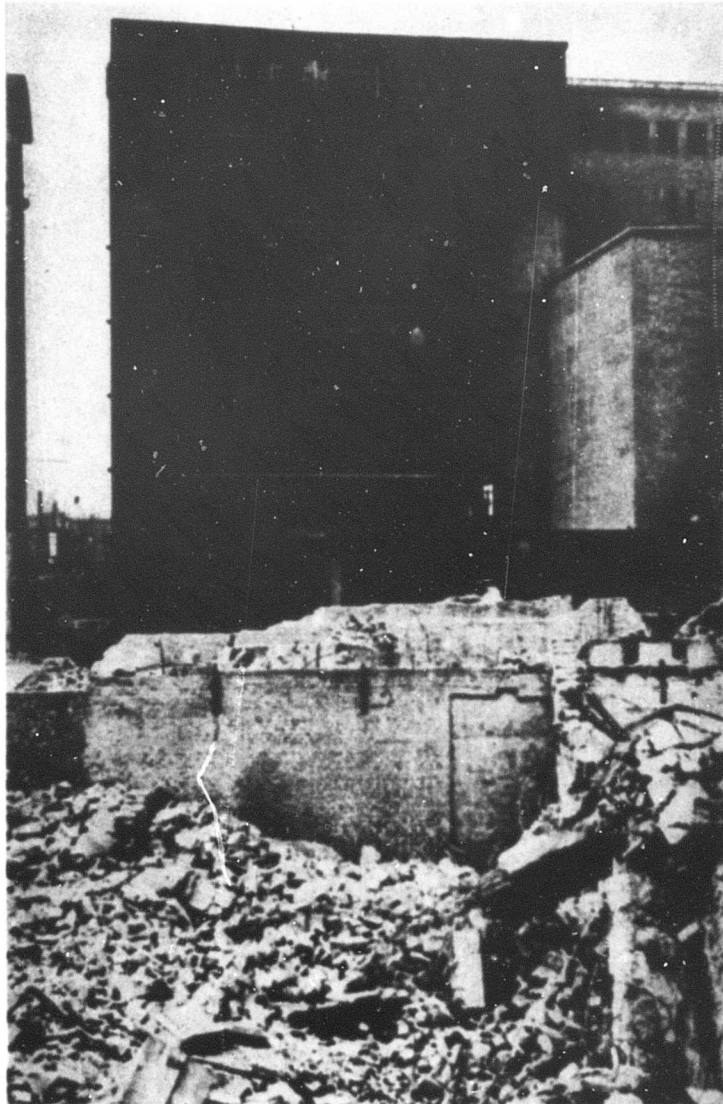
Picture 45 SOOT-BLACKENED STRUCTURES

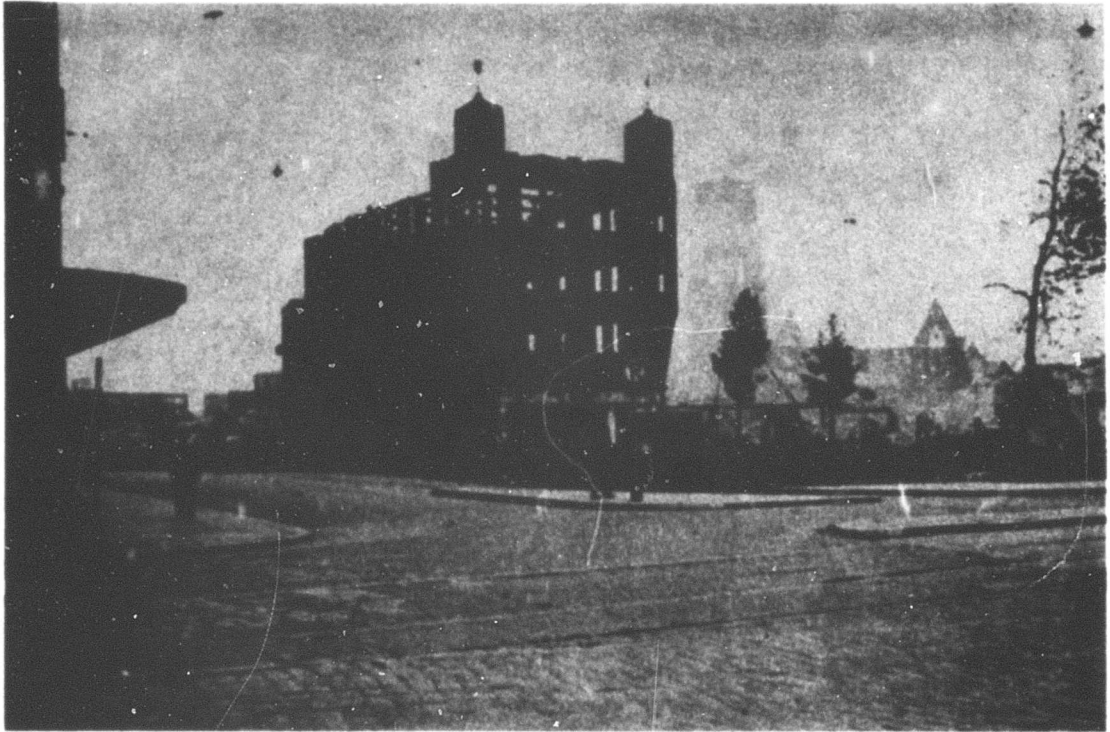
Pictures 46,47 SOOT-BLACKENED STRUCTURES

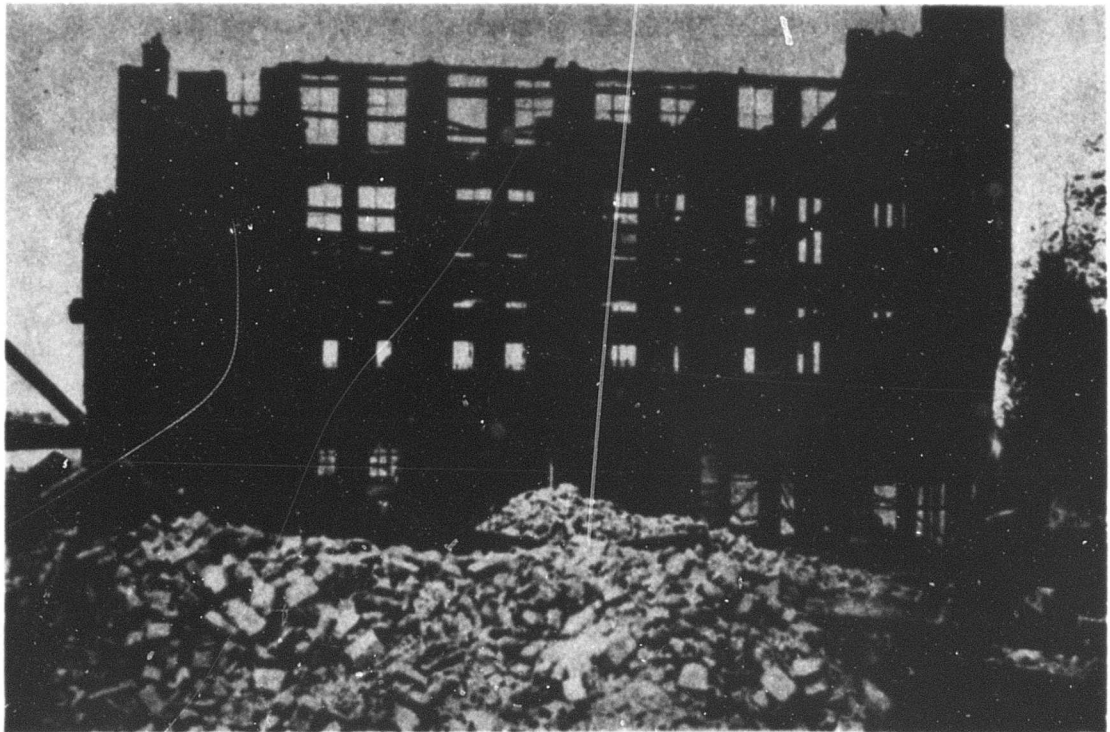
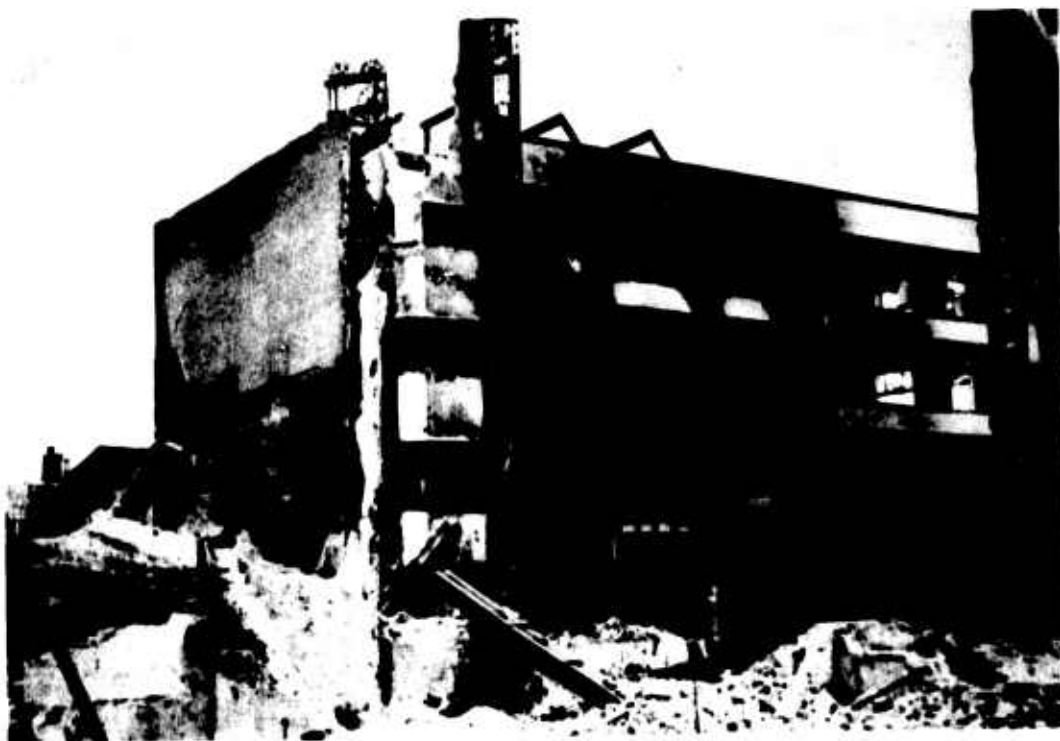
Pictures 48, 49 SOOT-BLACKENED STRUCTURES

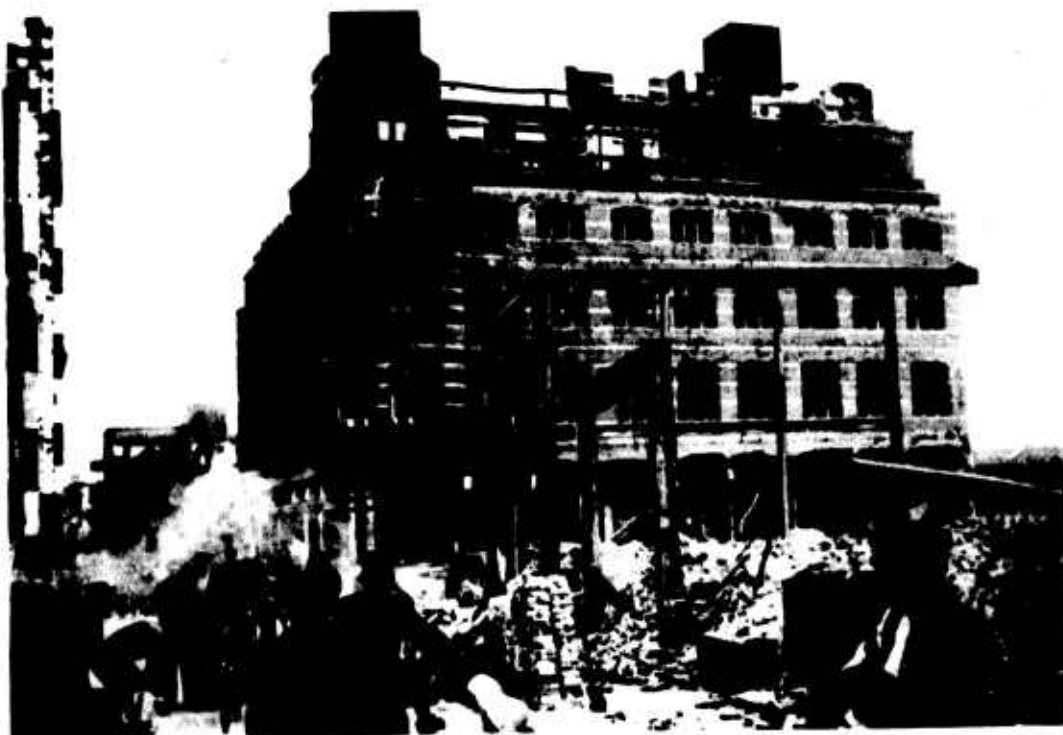
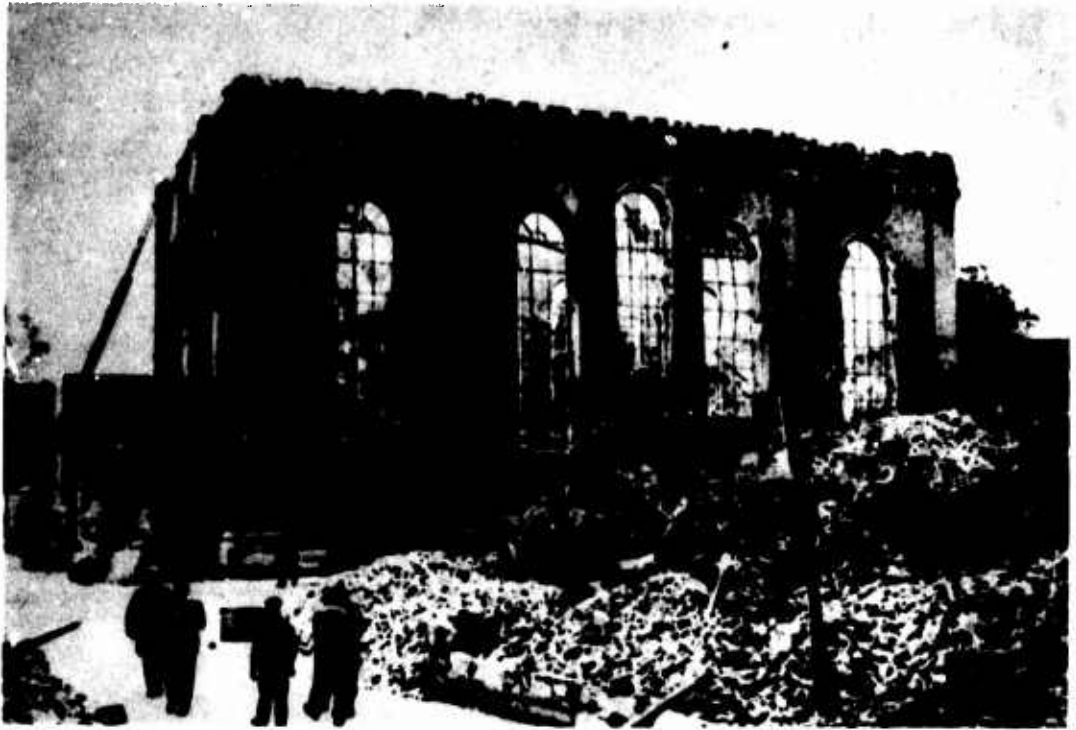
Pictures 50, 51 SOOT-BLACKENED STRUCTURES

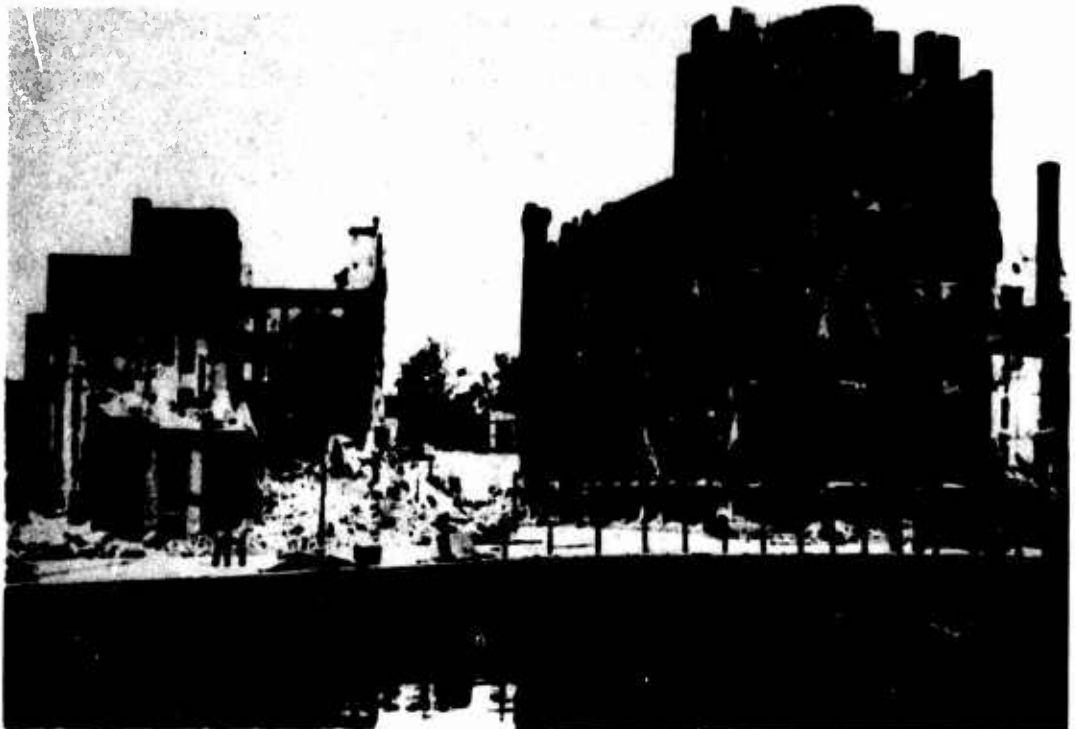
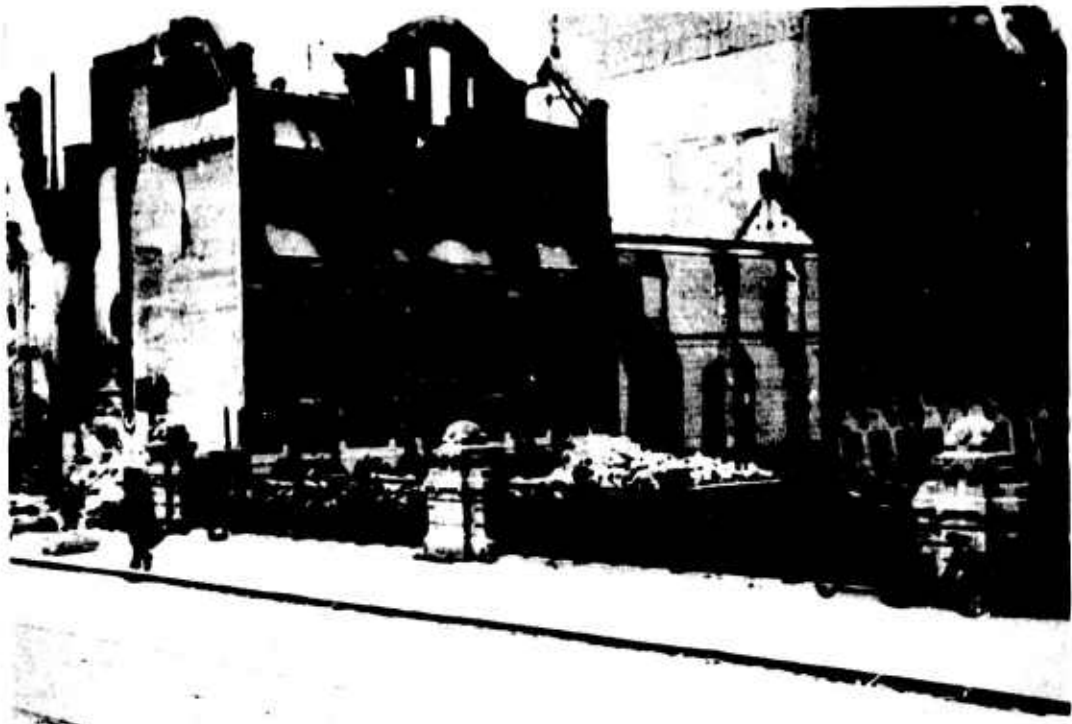
Pictures 52, 33 SOOT-BLACKENED STRUCTURES

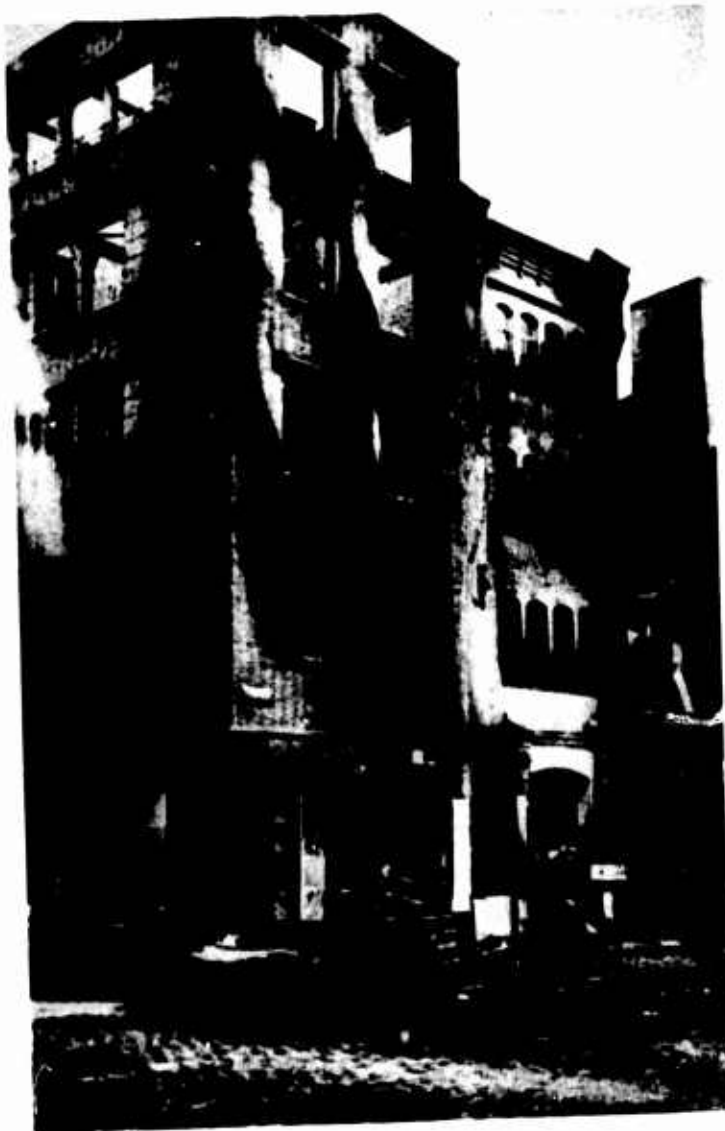
**Picture 54 SOOT-BLACKENED STRUCTURE**

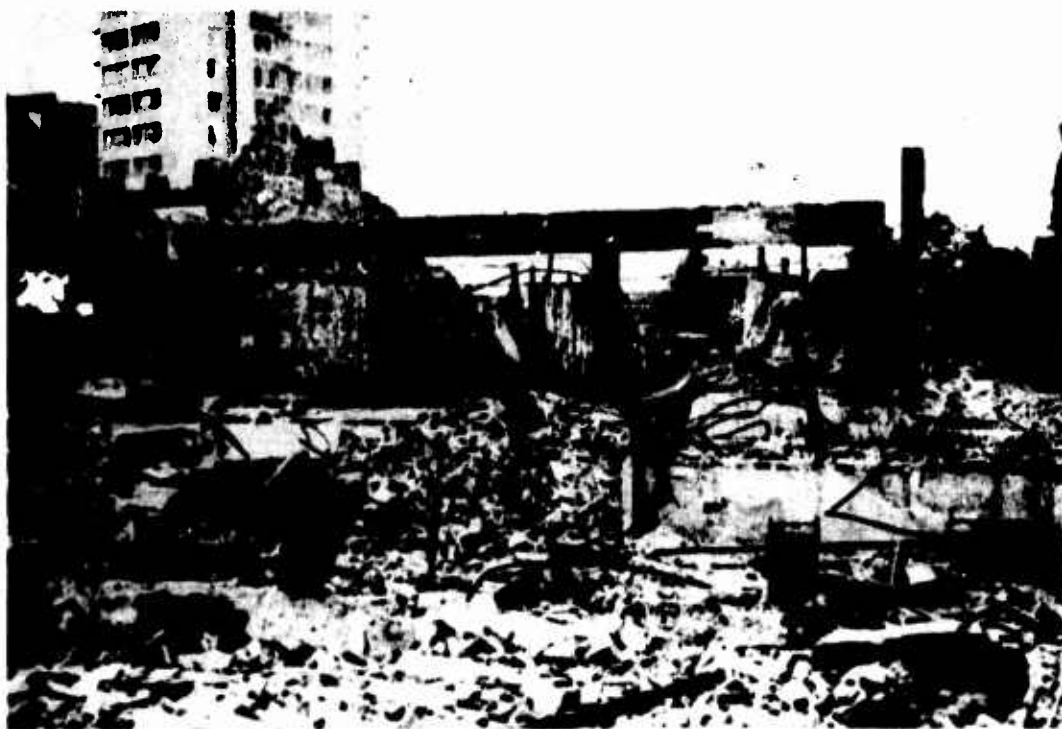
Another outstanding example of the fact that the destruction was caused by fire and not through high explosive bombs is presented by the skyscraper which the whim of the fire left standing intact (see city map, location b, Figure 1). Here all windows facing away from the wind were left undamaged. If the destruction of the neighboring houses had been effected by high explosive bombs, then all the window panes would have been broken due to the force of the detonation (see Picture 56).

**Picture 56**   **UNDAMAGED SKYSCRAPER SURROUNDED BY DEBRIS FROM FIRE-DAMAGED STRUCTURES**

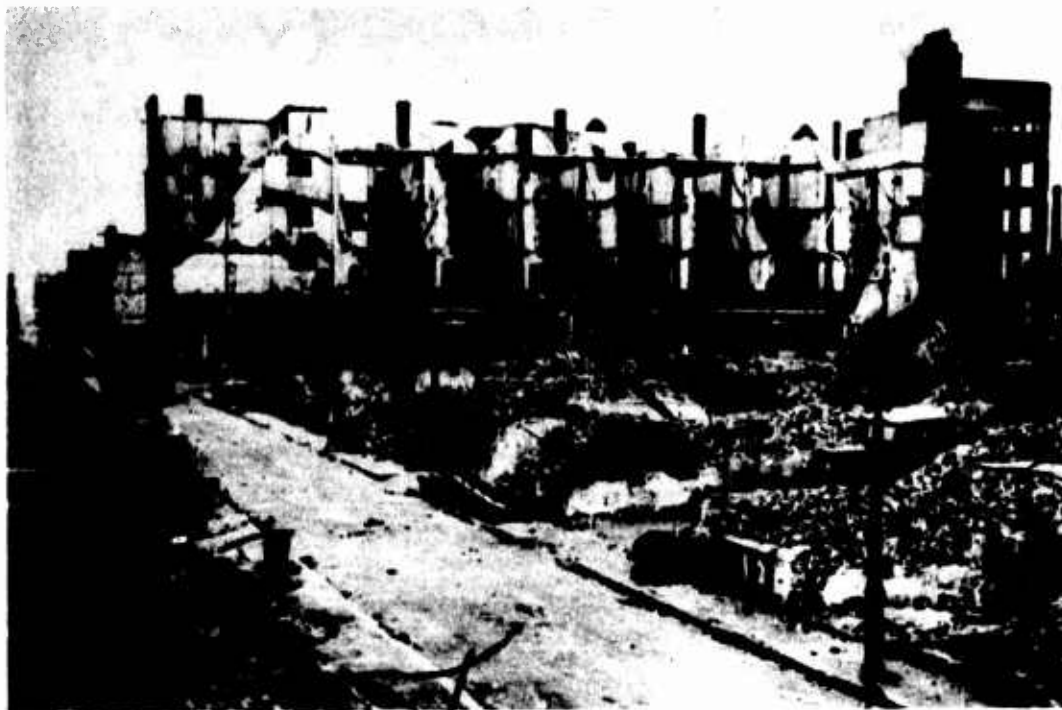
high explosive bomb, which destroys a city mansion in one hit (see Pictures 57 and 58).

Pictures 57, 58 BLAST-DAMAGED MANSIONS AND APARTMENTS
